## CONDITION AND FUTURE USE OF EARLY AGE STEEL BRIDGES IN A HISTORIC CITY

Philippe Van Bogaert\*

\* Civil Engineering department, Ghent University, Belgium  
e-mail: philippe.vanbogaert@ugent.be

**Keywords:** early age steel bridges, design load, assessment by real traffic data, condition of historic bridge, refurbishment alternatives.

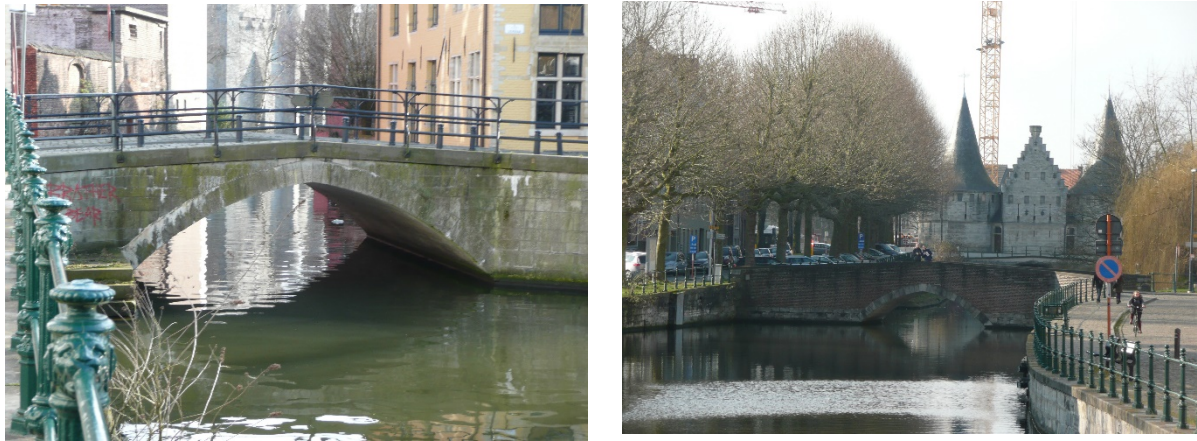
Figure 1: Lieve bridge (left) and Rabot bridge (right).

Of the remaining 124 bridges in Ghent, only 7 are authentic vaulted arches, built from sandstone or brickwork. These are all concentrated in the Northern part of the old town, where river Lys has not been navigable, already for a long time and the XII-th century canal Lieve towards the sea is closed down. Typical bridges are the Saint-Anthony bridge (left), rebuilt in concrete in 1954 and the Rabot bridge (right) oldest bridge in Ghent, built in 1860, both shown in Fig. 1.

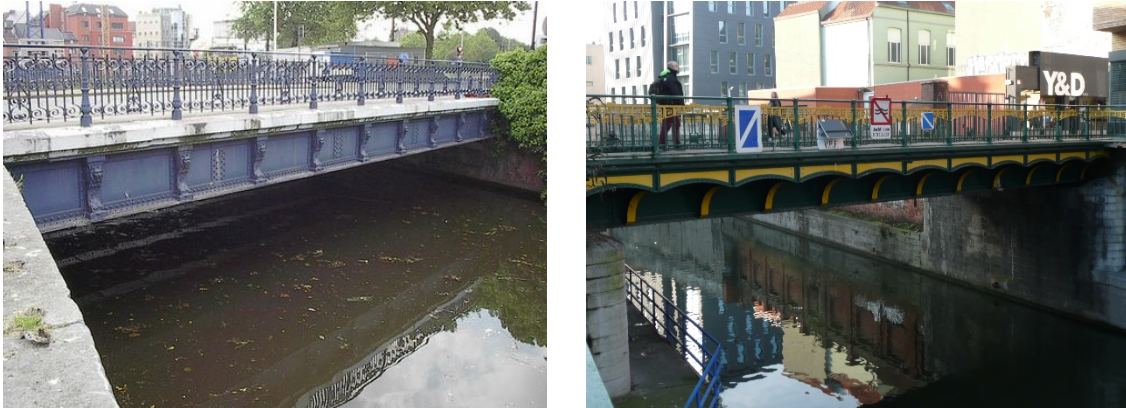
In order of age, these vaulted arch bridges are followed by a series of iron and early age steel bridges. In this series the E. Peynaertbridge, across an eastern branch of river Scheldt has luckily survived the many demolitions. This iron bridge, dating from 1883 consists of parallel I-profiles, connected by crossbeams. It is in acceptable condition as can be verified in fig 3 (left) and is used by local traffic. Apart from this bridge, apparently forgotten in any demolishment plans, a similar structure crosses the Cauldron canal, which was dug out already in the XIth century to demarcate the city limits. The Walpoortbridge is seen to the

right of Fig. 3 and is already from early steel. The design and style are very close to the Peynaertbridge.

Figure 3: E. Peynaert bridge river Scheldt (left) and Walpoort bridge (right).

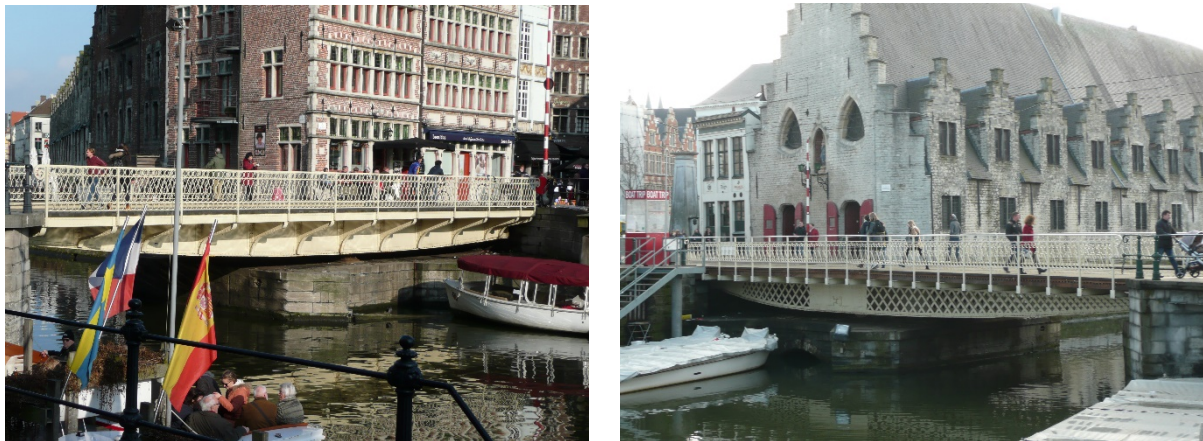
The 3 early age steel bridges, rebuilt for the 1913 exposition are discussed further. From 1984 to 1987 5 movable bridges were completely renewed according to the former design, including the use of riveted connections. All of them are swing bridges and the swing mechanisms have equally been replaced. Some of these have plain webs as the Grass Bridge (see fig. 4 left) and others have complex truss girders as Vleeshuis Bridges (fig. 4 right).

Figure 4: Rebuilt movable bridges. Grass Bridge (left) Vleeshuis Bridge (right).

The 5 rebuilt bridges were again thoroughly refurbished from 2012 to 2016, during periods of interruption to all traffic (including tramways), mostly by repainting and replacing the wooden deck. The bridges were completely wrapped and opened for shipping. In future, no motorized traffic will be allowed in the city centre. This will certainly increase the life cycle of all bridges. Finally, in 1973 one of the movable bridges was demolished and replaced by a movable cable-stayed bridge. The pylons are turning on wheels, supported by a concrete platform, easily seen in fig. 5 (left). During movement the pylons are vertically aligned by short stays, identical to the fan-arranged upper stays. This was a successful change and was followed by the replacement of the Kromme Wal Bridge, which then dated from 1872 and was a swing bridge. The new bridge was built in 1993 as a bascule bridge with the particular characteristic the counterweight is not fixed. The ballast box is normally empty and is filled with water from River Lys, when opened for shipping. The success of these bridges had led to

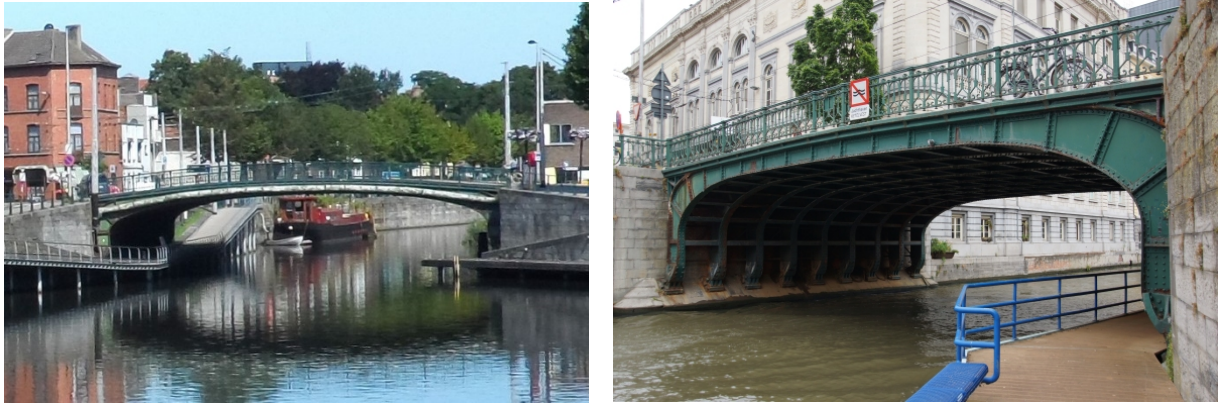
The Cauldron bridge, built in 1912, shown in fig. 8 (right) crosses the canal, connecting rivers Lys and Scheldt, dug already in the 11<sup>th</sup> century delimiting the medieval city to the South. It carries road traffic to 2 important squares of the city, the commercial centre and the old court of justice. The bridge is also crossed by the main tramway line of the city.

Figure 8: Design load motorized tramways.

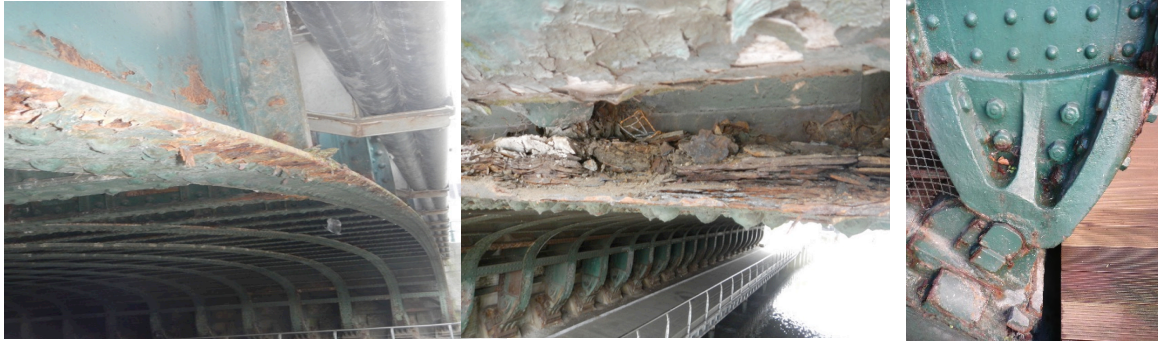
The hinged supports were inspected more in particular. Already fig. 10 shows a rather bad condition. However, after manual brushing, hammering and subsequent local grinding, the corrosion of these parts appeared equally superficial and limited to less than 1 mm. Most probably the hinge is not sufficiently functioning and will require serious refurbishment.

Figure 10: Corrosion of outside frames and hinged support.

These various inspections clearly showed that the outside frames are heavily corroded at the most exposed parts. At the frame centre, more than half of the lower flange has disappeared, whereas at the portal nodes and posts, the former applies to the upper flanges. At a single inner frame the vertical post is heavily corroded. A detailed inventory of all these reduced cross-sections has been made and was implemented in a numerical model of both bridges.

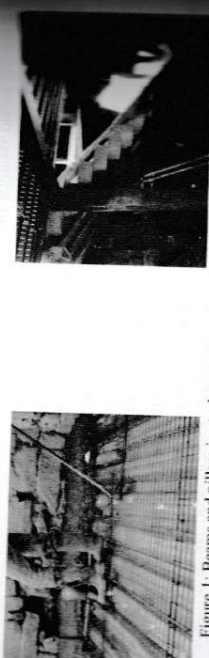
Option C has better results and involves the use of a steel structure (beams and pillars) and steel decking for concrete floors slabs, figure 1. On the other hand, the option B has the lowest results in the quantification of environmental impact categories, but one that has the most advantages in relation to the specificities of the building type, quick assembly and is the one that best responds to the existing constraints.

Figure 1: Beams and pillars in steel structure and steel decking for concrete floors slabs

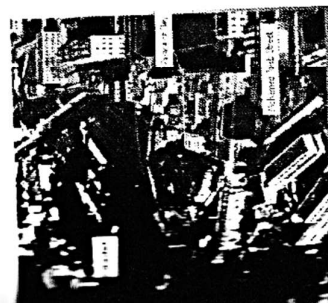
Figure 1: Aerial photo of the Citadel

The Casbah of Algiers contains many historical monuments dating from the time when Algeria was under Ottoman rule, especially the Citadel located in the Casbah. This Citadel is a set of buildings whose Dey Palace is one of them (figure 1). To allow a junction between the old city (Casbah) and the new city, a road was opened through the Citadel at the end of the 19th century.
